20 years of experience with FRP at desulfurization plants

Dipl.-Ing. Reinhard Lux, Christen & Laudon GmbH
Bitburg Staffelstein, Germany (www.Christen-Laudon.de)

This paper is primarily about blistering in FRP components operated with water-vapor saturated media. Several theoretical publications from the 1980's have been confirmed by the operational experiences of the last 20 years. As a result of these experiences, details about better methods of manufacturing for FRP components are given in hopes of moving the industries' standards forward.

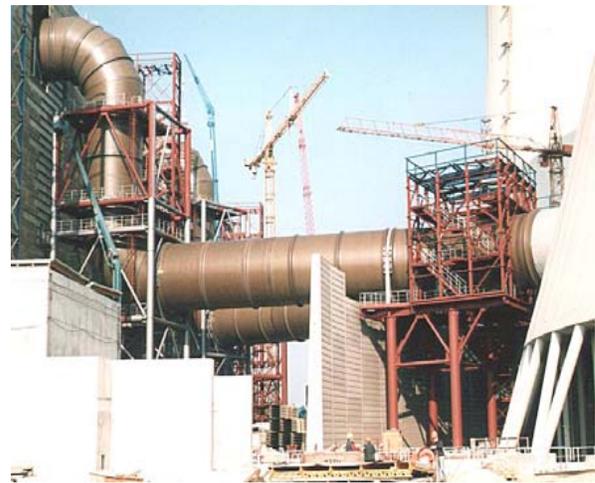
Image 1.2: Flue gas duct (21'-4"Ø) at Schwarze Pumpe

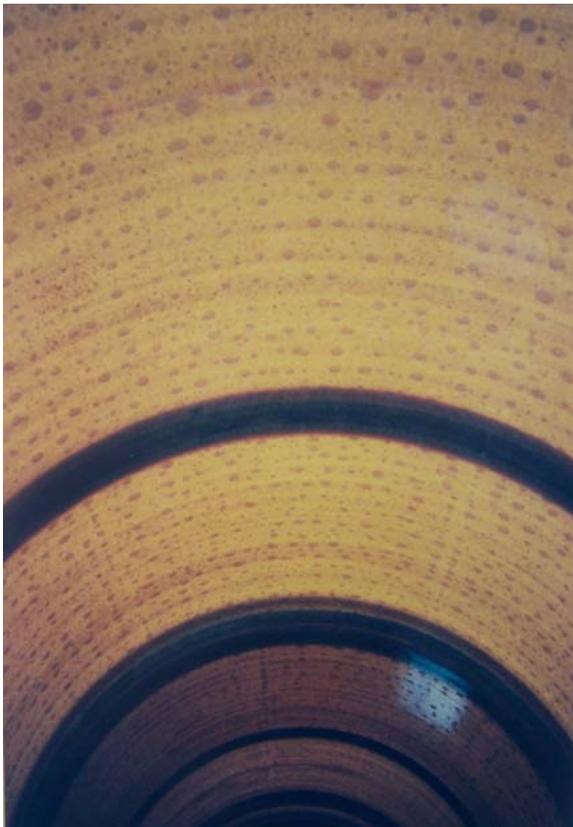
Image 2.1: Small blisters in a flue gas duct

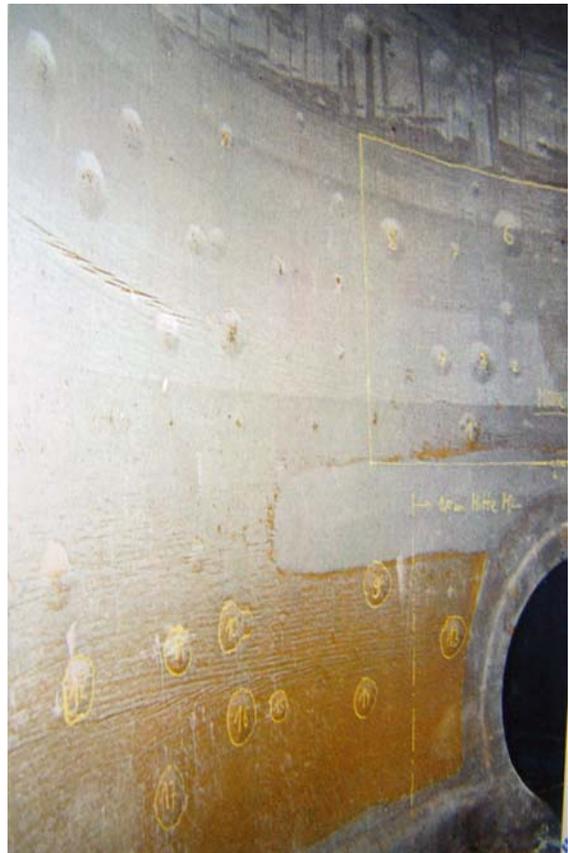
Image 2.2: Blisters in a storage container

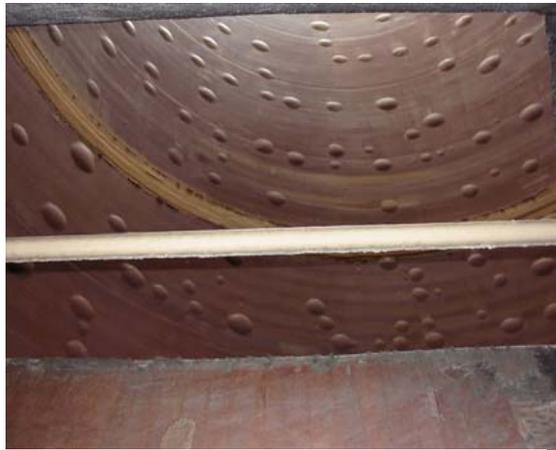
Image 2.3: Bigger blisters in a flue gas duct

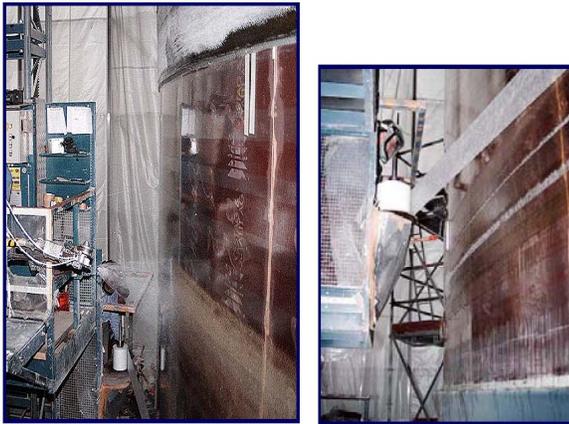
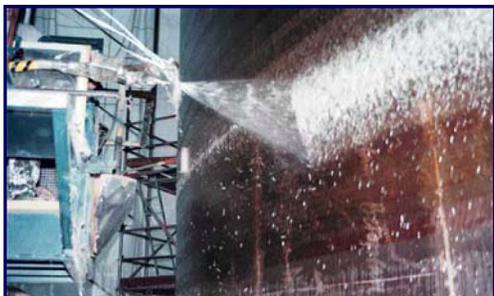
Image. 5.1: Production “wet in wet”

In order to produce wound laminates “wet in wet” the manufacturer has to be very experienced. Also, the right equipment (Image 5.1) is needed for manufacturing a successful part.

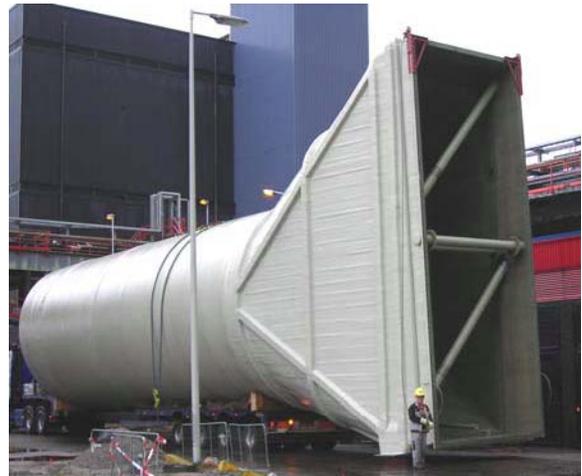
Image 6.3: Insulated 17'Ø flue gas duct section, connected to 10'x30' breaching

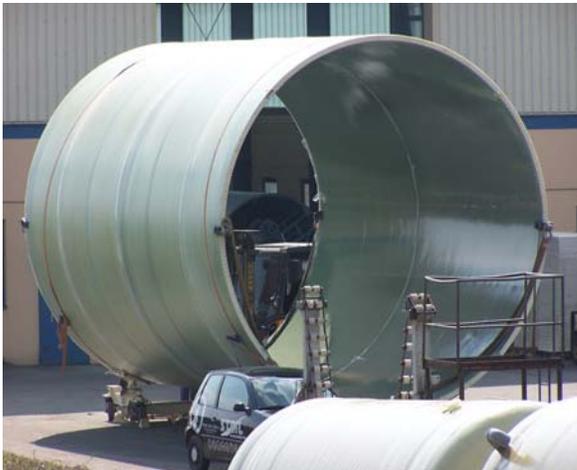
Image 6.1: Insulated 17'Ø flue gas duct section

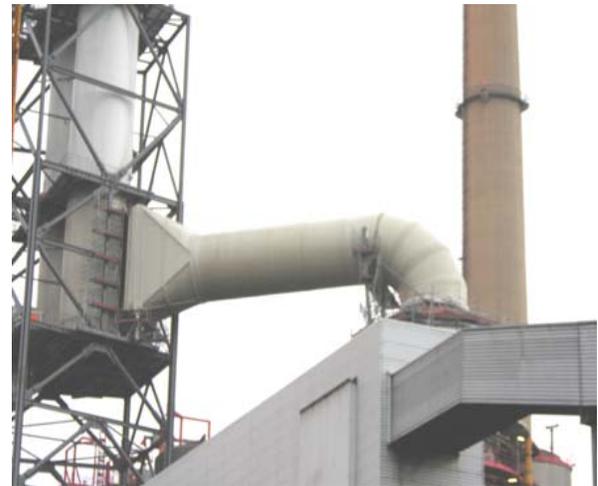
Image 6.4: Assembled FRP flue gas duct with the breaching connection to chimney

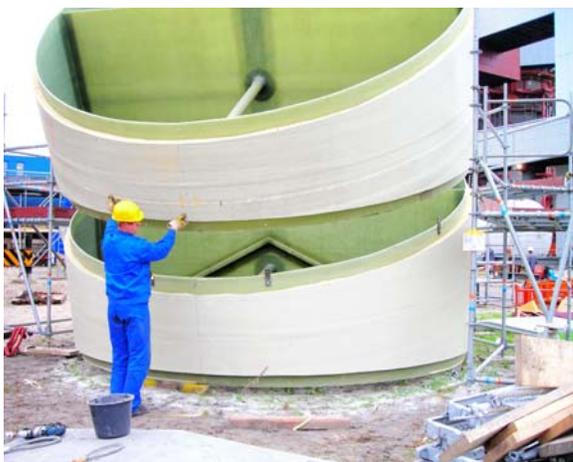
Image 6.2: Pre-assembly of a 17'Ø mitered elbow
